Report

Karaaf Wetlands Catchment – Ecological and Stormwater Assessment

The Sands Owners Corporation

15 October 2021

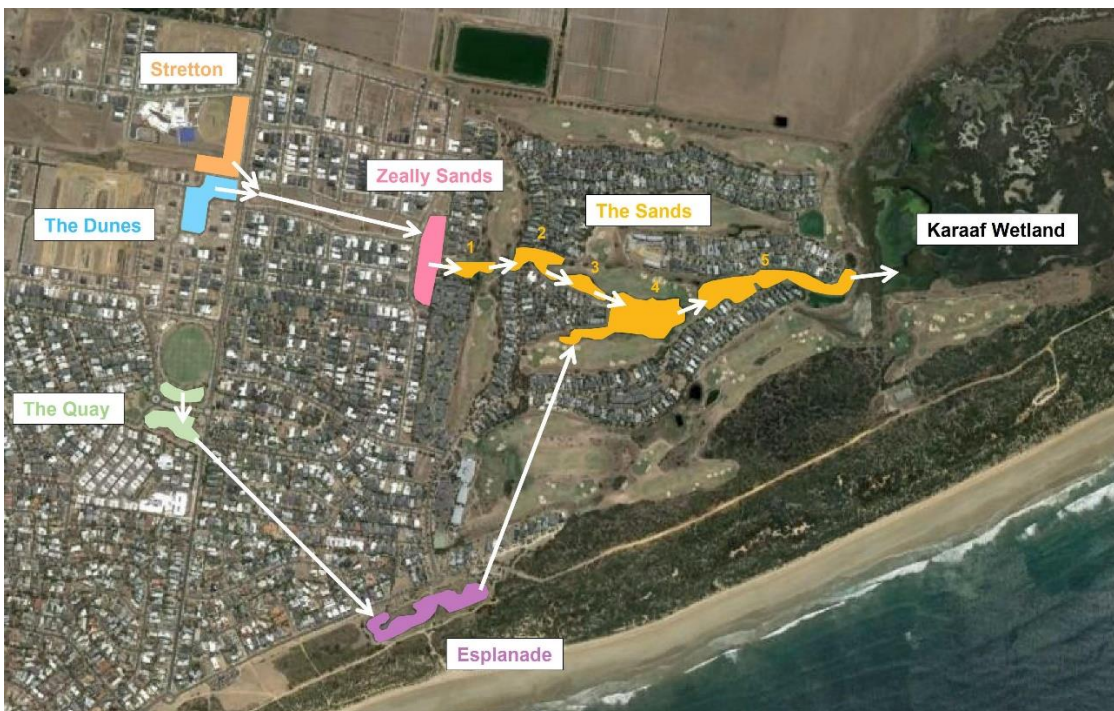
Figure Figure 1--3 provides a schematic diagram of the constructed wetlands that feed stormwater through The Sands development into the Karaaf Wetlands.

FIGURE 1-3 CONSTRUCTED WETLAND LOCATIONS AND FOW PATHS

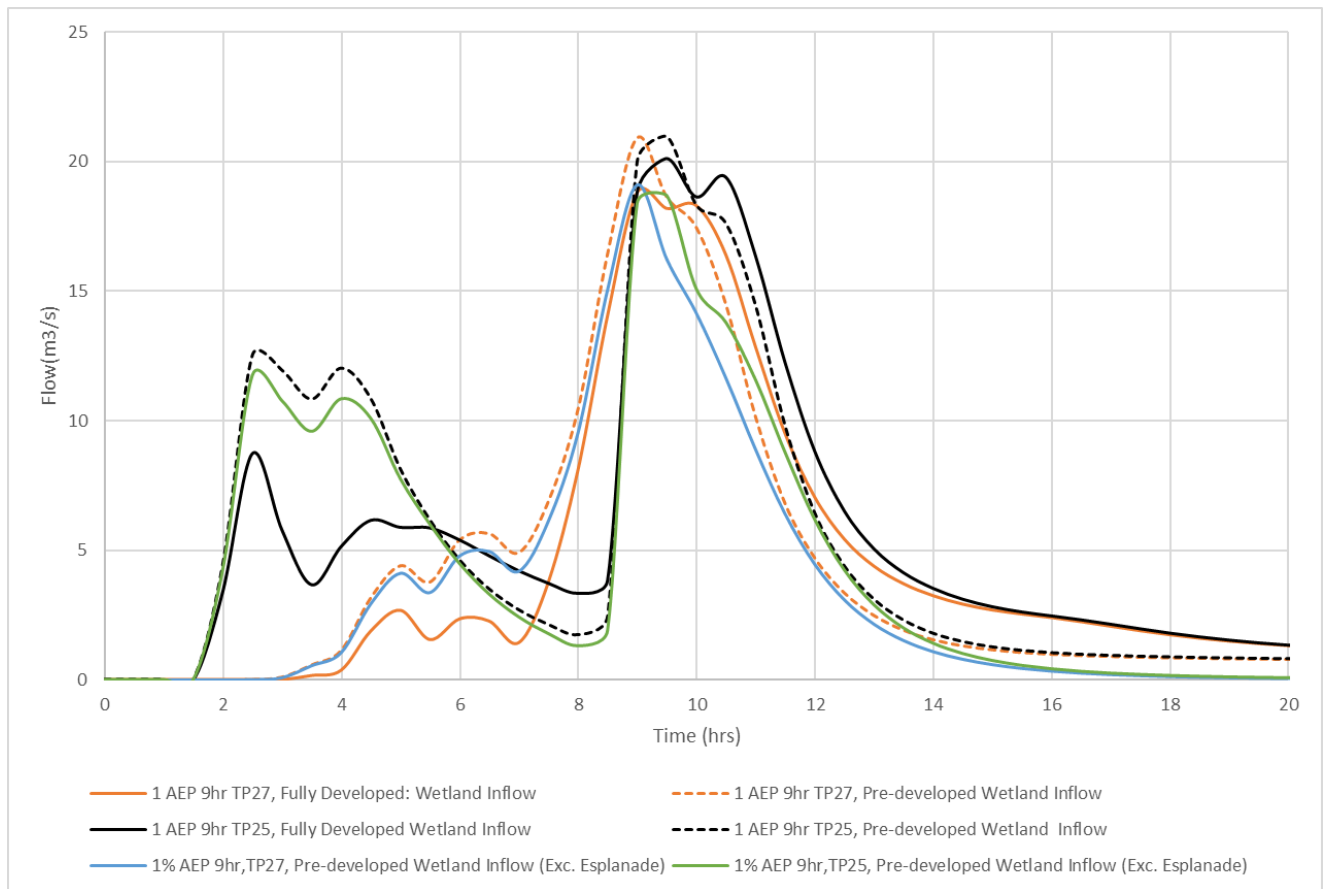
FIGURE 2-7 SANDS TORQUAY - KARAAF WETLANDS INFLOW (1% AEP, CRITICAL DURATION)

The RORB model results suggest that for the 1% AEP design flood the development of the catchment has resulted in a reduction in peak flows due to the active storage and controlled outlets provided in the wetland-retarding basins. This occurs when comparing both the pre-development and pre-development excluding the Esplanade wetland catchment connection with developed conditions. Whilst the diversion of the Esplanade catchment does contribute to a minor increase in overall peak flows, the timing of the peak of these flows is not at the same time as the Torquay North catchment. Subsequently the impact of the increase in catchment area draining to the Karaaf Wetlands is not predicted to be significant.

The development has resulted in an overall increase in flood event flow volume into the Karaaf wetland. A comparison of these results shows that the volume for the 1% AEP fully developed conditions design flood, when compared to the pre-development and pre-development excluding the Esplanade catchment, is increased by 8% and 38% respectively.

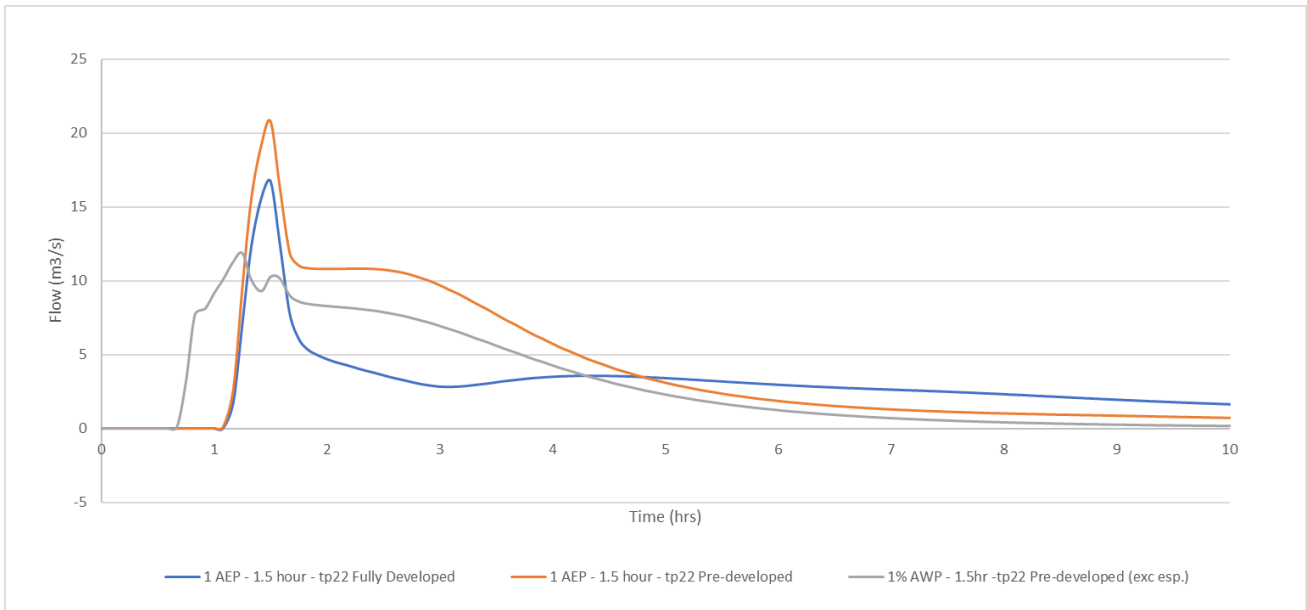
FIGURE 2-8 SANDS TORQUAY - KARAAF WETLAND INFLOW (1% AEP, 1.5 HR DURATION)

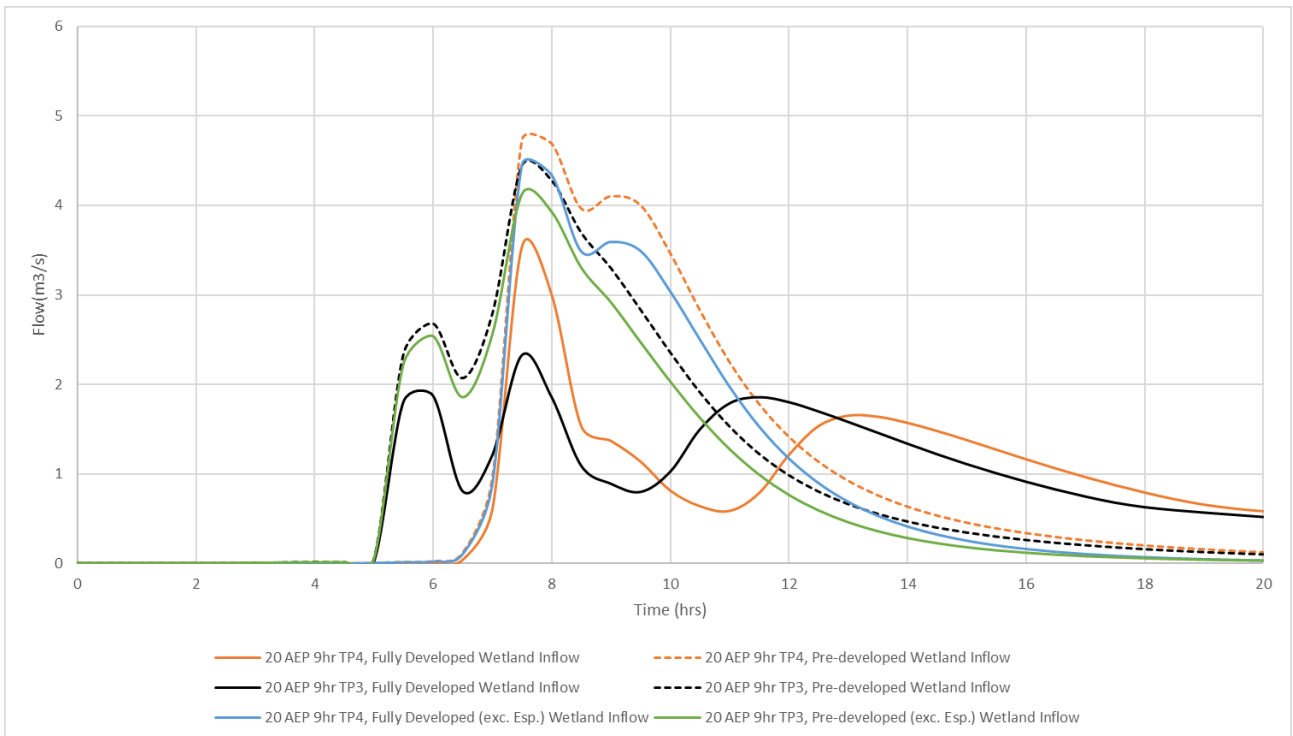
FIGURE 2-9 SANDS TORQUAY - KARAAF WETLAND INFLOW (20% AEP, CRITICAL DURATION)

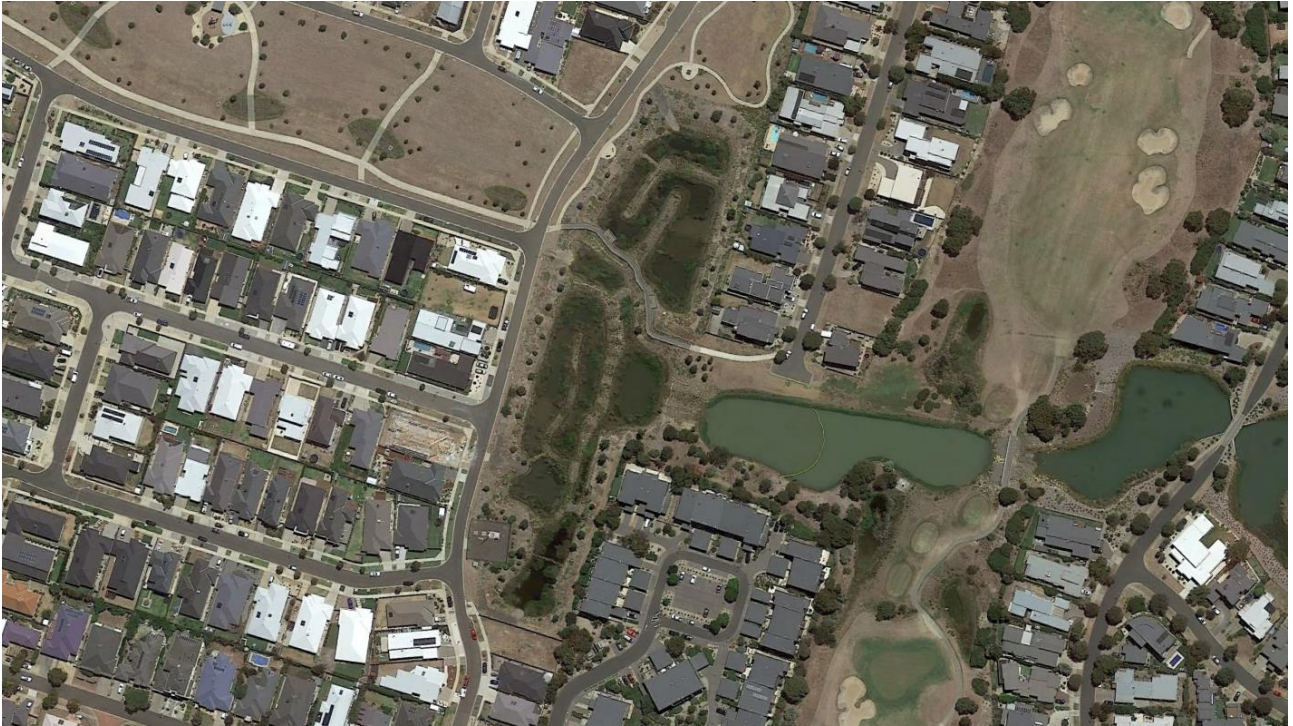
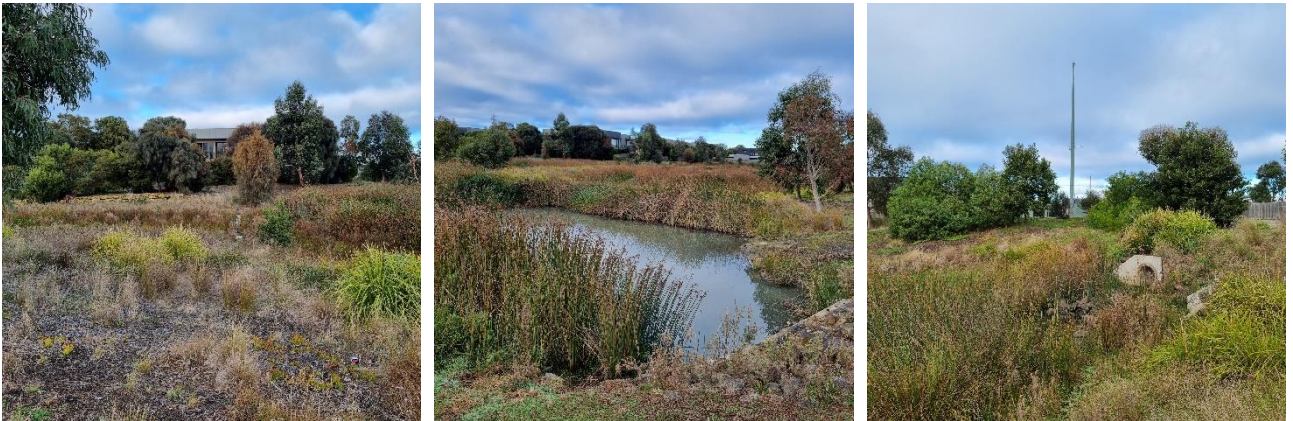
FIGURE 3-1 ZEALLY SAND WETLAND PHOTOGRAPHS

- Due to sedimentation and vegetation growth, it is likely that any low flow/balance pipes between the wetlands pool are blocked. This is likely to compromise the functionality of the wetland.

- Plant diversity within the wetland appeared to be limited. This was also evident within the fringing and adjoining landscaping.

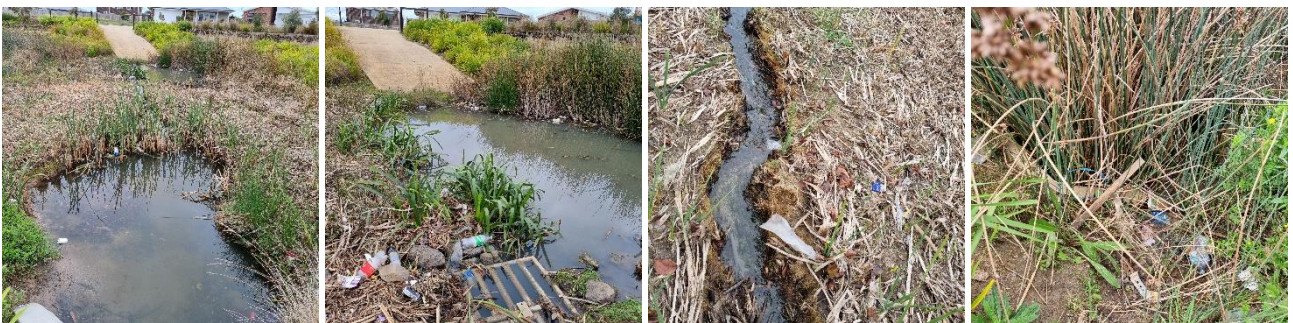
FIGURE 3-2 DUNES WETLAND PHOTOGRAPHS

- A significant amount of gross pollution was present within the wetland
- The water level in the sediment pond was above Normal Water Level (NWL)
- The southern sediment pond appeared to have exceeded its capacity with inflows scouring a path through the accumulated sediment.
- Some sediment pond inlets were not visible and likely not functional due to accumulated sediment and vegetation overgrowth. At the time of inspection the two northern inlets were discharging to a single water body.
- Water within the wetland was notably turbid, although no water quality sampling was undertaken at this time to confirm levels.

- The north-western pipe inlet was severely obstructed with vegetation, debris and sediment.
- 3 Gross Pollutant Trap (GPT) devices were identified at the inlet locations to the wetland. No inspection of these devices was possible. It is also noted that an additional GPT was identified within the eastern access driveway. This GPT does not appear to align with the inlet of the wetland in accordance with available plans and councils pipe network database.
- It appeared that some management of vegetation at the southern sediment basin had occurred as visible by the vegetation debris at this location.
- All three inlet pipes were partially drowned at the time of inspection.
- There was a visible lack of aquatic vegetation within the wetland.

- b. Immediate servicing of existing GPTs within the Dunes Wetlands, initiate inspection program of these assets at frequency intervals of no less than 3 months, until such time as the wetlands and developing catchment is considered stable. This inspection program should also include, as required, maintenance and cleaning of these structures. Undertake immediate works to reinstate catchment wetlands to “as designed” condition including verification of operational levels, sediment basin remediation, control structure inspections and vegetation planting (pipe connections, outlets weirs etc.). Consideration should also be given to the need for installation of litter traps as pre-treatment for existing and future wetlands which otherwise solely rely on the wetlands managing gross pollutant loads from the system.

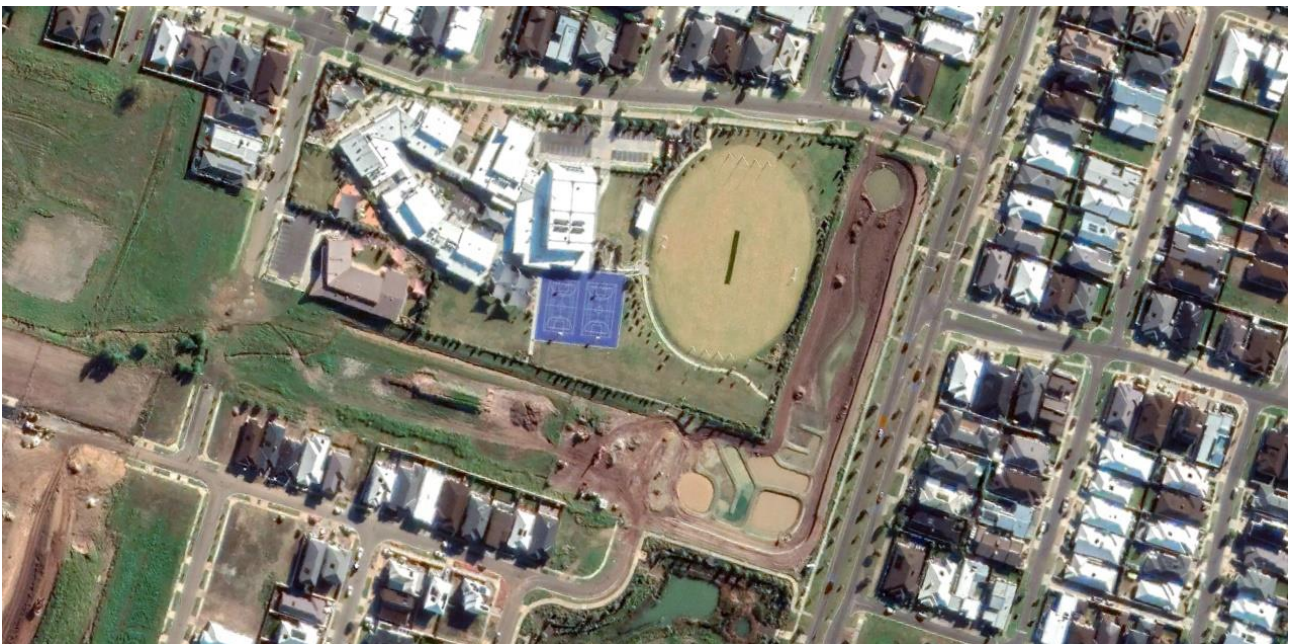
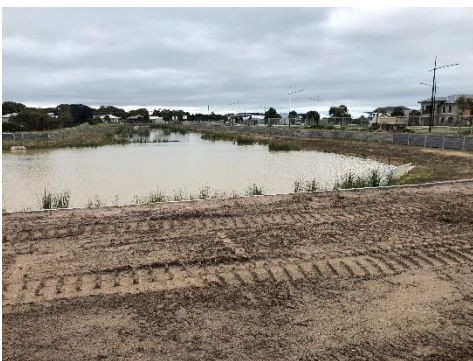
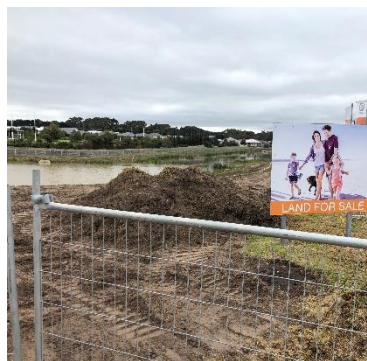
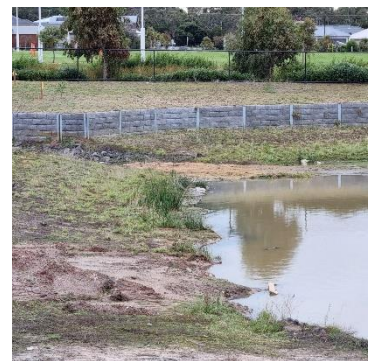
FIGURE 3-3 STRETTON WETLAND PHOTOGRAPHS

appears that since this time the wetland is retaining higher than design water levels with water levels lower than the apparent wetland outlet located in the south eastern corner of the wetland.

- Water was visibly turbid.
- Whilst some vegetation appeared to have established within the northern part of the wetland, it did not appear that aquatic vegetation planting had occurred and or that landscaping of the banks and riparian area had occurred.
- A high degree of disturbed soil was present around the wetland with limited visible sediment control in place.
- A large area of sediment and sand appeared to have deposited immediately downstream of the inlet within the southwest corner of the wetland.
- No sediment control was visible within the estate related to stormwater pit entries.

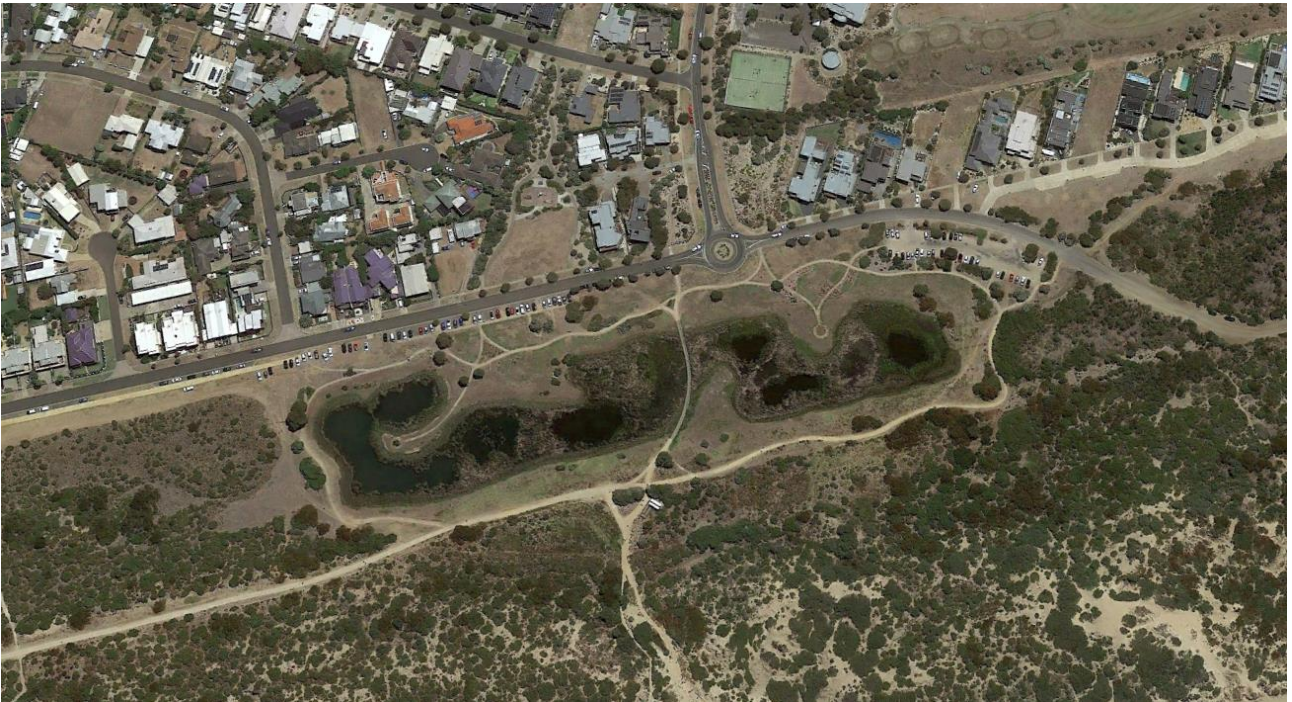
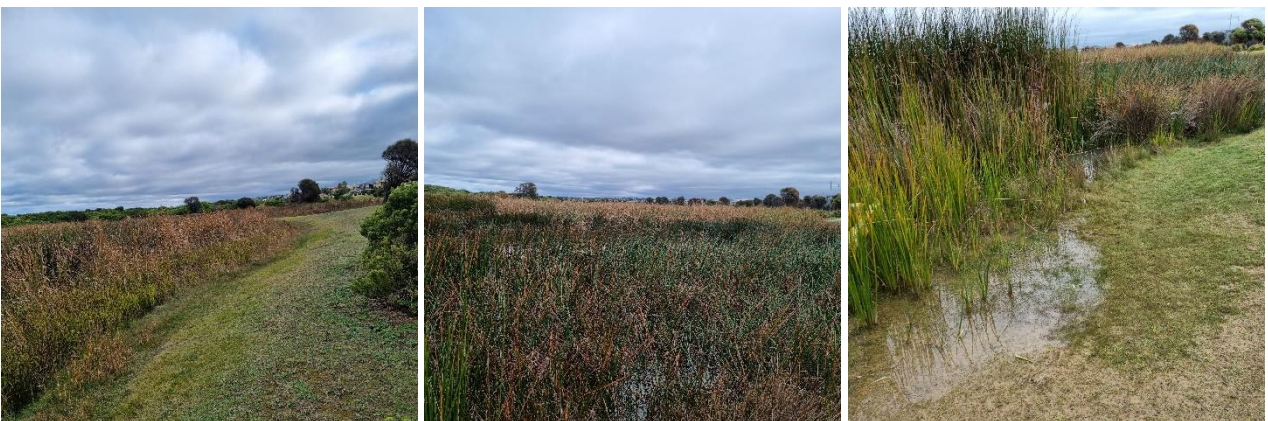
FIGURE 3-4 ESPLANADE WETLAND PHOTOGRAPHS

- No visible gross pollution was present within the wetlands

- Water levels within the wetland were relatively high with inundation extending out of bank to the north of the outlet at the time of inspection.
- The wetland outlet was not visible and appeared significantly obstructed by vegetation overgrowth.
- Water was audibly flowing from the wetland at the time of inspection.
- Whilst vegetation health within the wetland appeared good, Typha, a designated weed of the Surf Coast Shire was identified within the wetland.

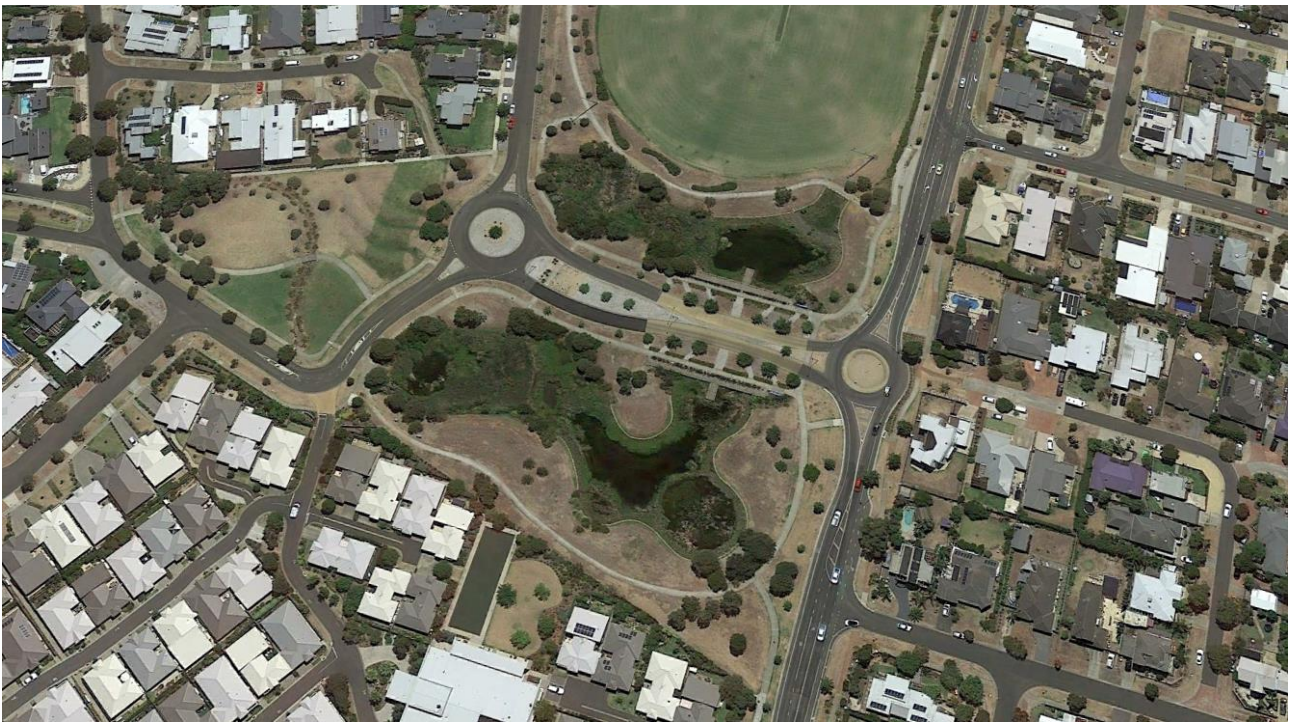
FIGURE 3-5 QUAY WETLAND PHOTOGRAPHS

- Minor gross pollution was present within the wetland

- No visible sediment pond or separated treatment areas.
- Vegetation overgrowth was present around the wetland inlets, although they did not appear blocked by vegetation.
- There appeared to be significant shallowing of some parts of the wetland with identifiable sediment deposition within the wetland.
- Typha, a designated weed of the Surf Coast Shire, was present within the wetland.
- Whilst there was good vegetation coverage within the wetland it appeared that some non-native species had established.

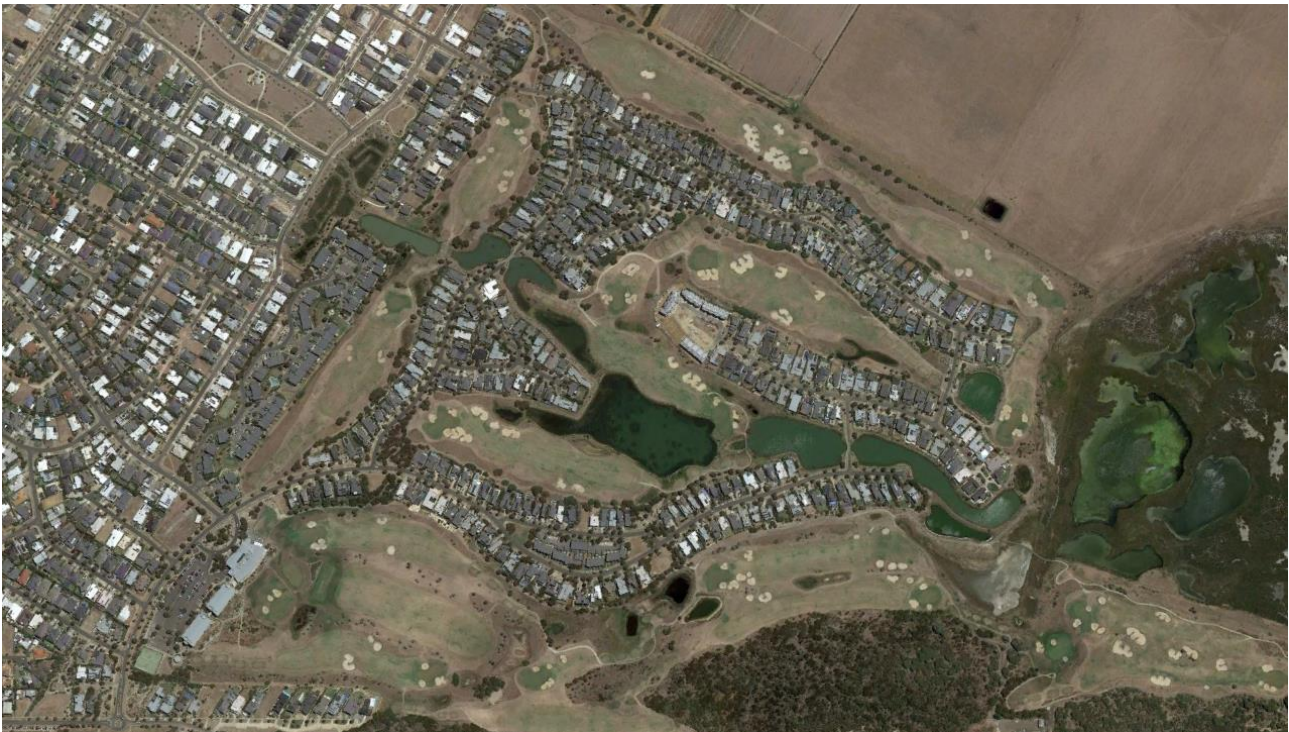
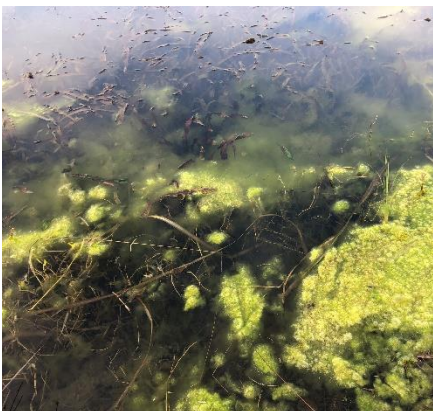
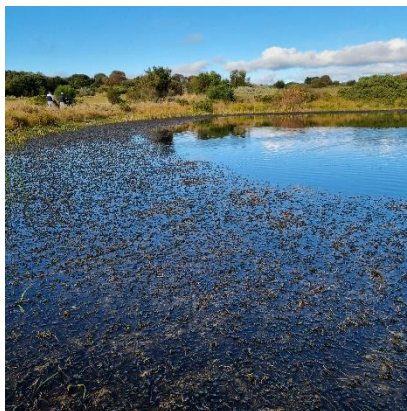
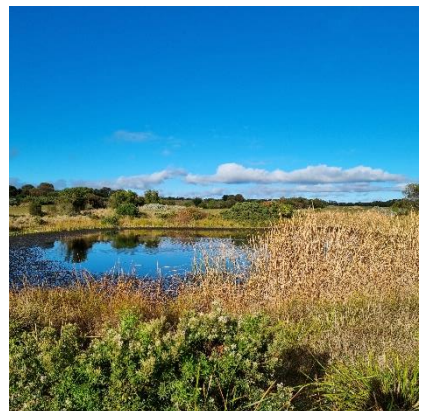
FIGURE 3-6 THE SANDS WETLAND PHOTOGRAPHS

- No gross pollution was present within the amenity lakes or treatment wetlands.
- A pollution bund was present within the first amenity lake adjacent to the Zeally Sands wetland.
- The wetlands had a good distribution of aquatic vegetation species
- It appeared that recent weed control had occurred.
- Turbidity within the lakes appeared to progressively decrease through the amenity lakes.
- Minor flows were discharging to the Karaaf Wetlands at the time of inspection via the concrete spillway along the eastern boundary of the estate.
- A number of the amenity lakes were observed to have a filamentous algae growth.

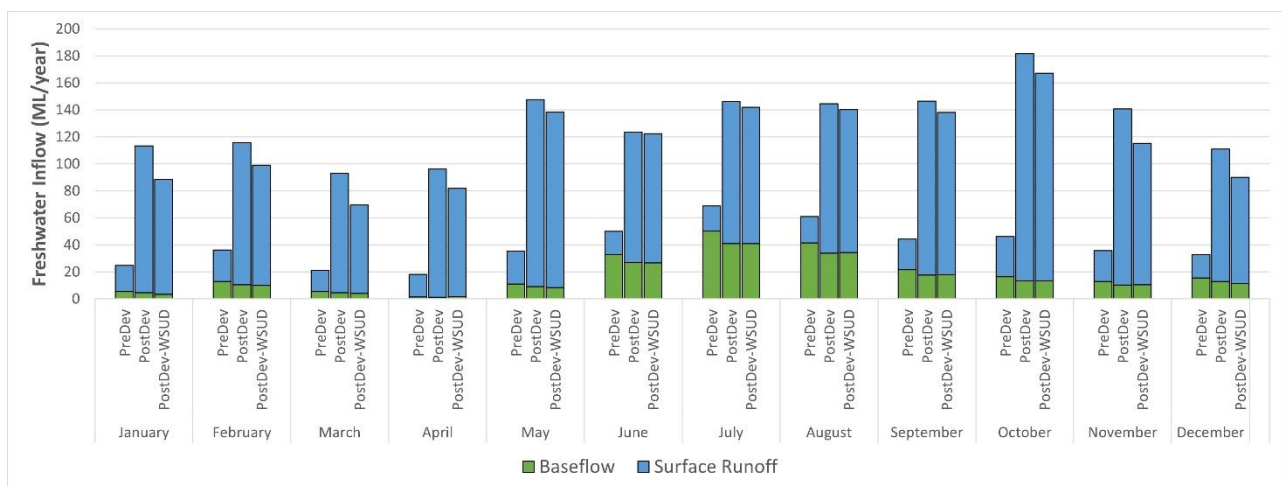
Sensitivity analysis was conducted by separating baseflow from the surface runoff (Figure 4-2 and Table 4-9). As expected, baseflow volume was decreased under post-development conditions. On average, ~19% reduction in annual baseflow volume was observed. On the other hand, model results indicated that the surface runoff would increase by 355% under post-development without mitigation scenario. These results reinforce the need for significant runoff volume reduction. The evaporation losses through proposed WSUD assets, 12 ML/y stormwater diversion at the Dunes development and the stormwater harvesting at the golf course was only able to reduce 12% of the post-development surface runoff volume.

FIGURE 4-2 FRESHWATER INFLOWS UNDER PRE-DEVELOPMENT AND POST-DEVELOPMENT SCENARIOS

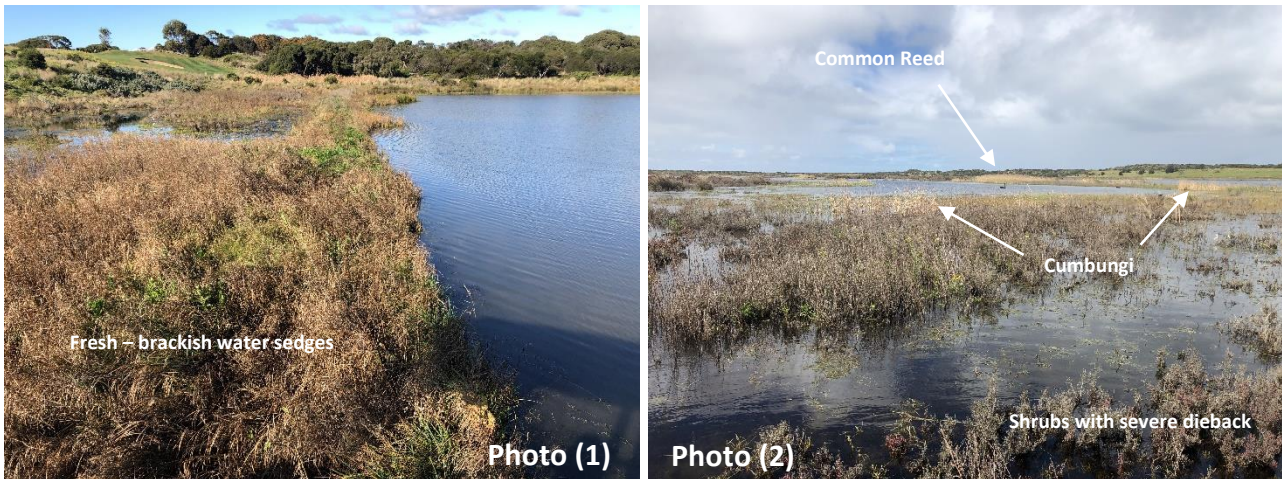
Dieback of the dominant shrubs, Shrubby Glasswort (*Tecticornia arbuscula*), was apparent during field inspections. The reported displacement of saltmarsh vegetation along the western fringe of the wetland was evident, with freshwater species dominating the margin adjacent to The Sands (see Photo 1 in Figure 5-3). Photo 2 was taken approximately 75 m in from the north-eastern wetland margin, looking centrally showing severe shrub dieback and the emergence of Cumbungi (*Typha* sp.) and Common Reed (*Phragmites australis*).

FIGURE 5-3 PHOTO 1 – FRESHWATER SPECIES, PHOTO 2 – SHRUB DIEBACK AND TALL MARSH EMERGING

The lack of saltmarsh shrubs along the western margins of the wetland suggests the combination of previous disturbance, and freshwater inputs are having a tangible impact on the vegetation structure and community.

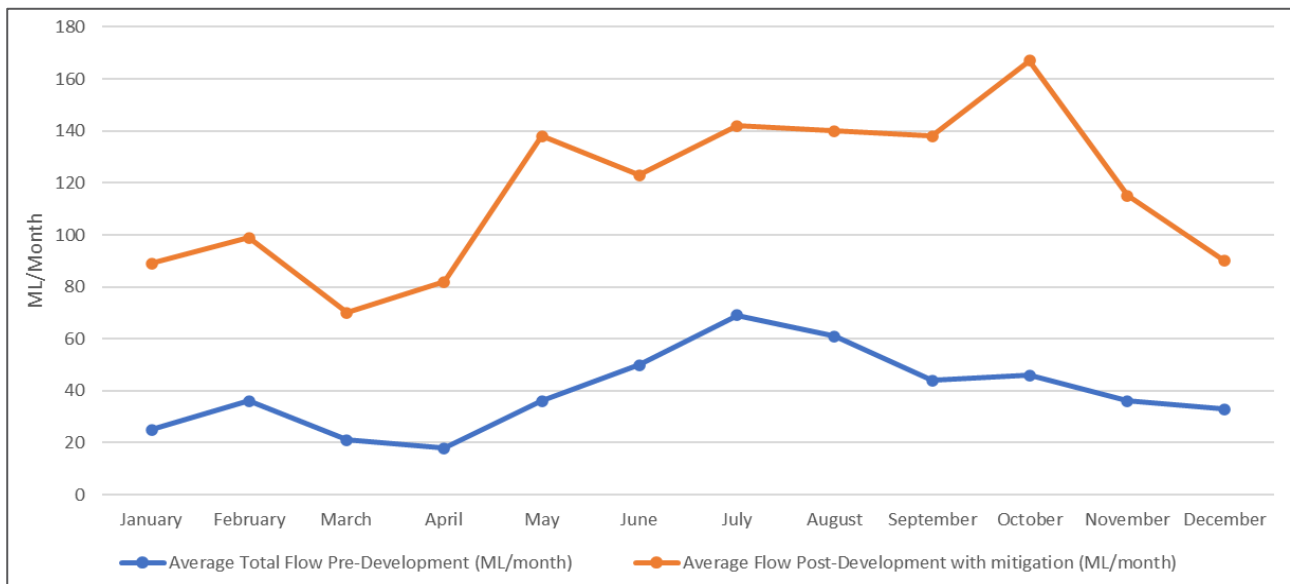
FIGURE 6-1 DEVELOPED CATCHMENT VOLUME DIFFERENCES
